BITS: A Key Performance Indicators (KPIs) supported approach to assess traffic safety for cyclists at intersections in the Netherlands

Johannes Schering

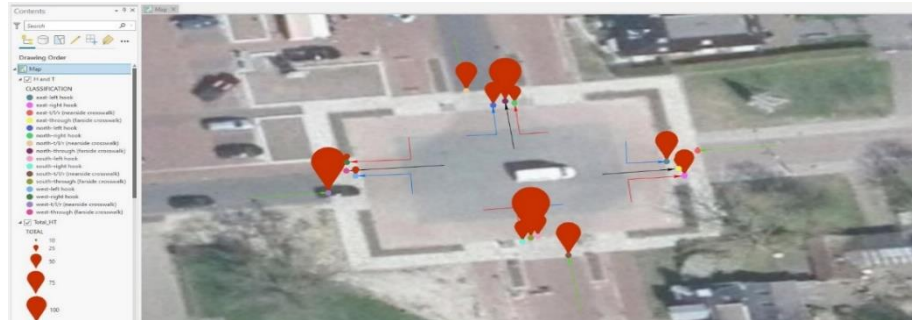
Fig.1: Near Accidents at Haadwei and Thiedamawei. Source: ArcGIS, copyright by Esri.

Many critical situations between cyclists and vehicles are happening when cars driving through and leaving the intersection on the north-south axis. The coloured arrows in Fig. 1 indicate the driving direction of the vehicles. A lot of situations are happening when the vehicles are approaching from western direction. At the northern and the southern axis more than 300 critical situations at each side were detected. At the eastern approach more than 200 near accidents were registered during the measurement.

Vehicle speed levels were divided by the time to collision. The most conflicting situations are happening when vehicles approaching from the northern, southern or western direction. Turning to the left or to the right side is less critical. The risks are quite equal spatially divided to all four corners of the intersection.

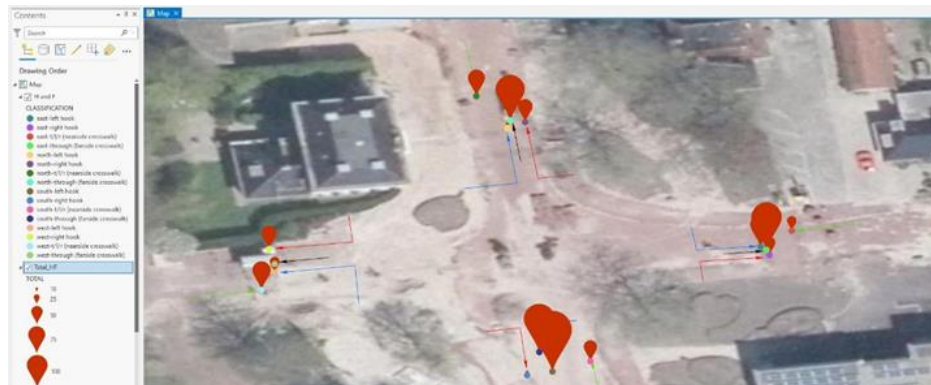
Fig. 2: Near Accidents at Haadwei and Foarwei. Source: ArcGIS, copyright by Esri.

The detection of near accidents took place at four days in June 2019 from 7 am until 11 pm. There is a conflict hotspot at the southern axis with more than 300 situations especially when cars driving through or turning to the left side (Fig. 2). Vehicles that driving through and leaving to the northern axis are also highly relevant. More than 250 situations were detected in the northern part what is a little bit less compared to the first intersection. Many situations (>250) are happening at the eastern approach.

Haadwei-Foarwei which is nearby was also rebuilt as a shared space concept. If there are approaching vehicles from more than two sides this can lead to confusion what is especially the case in the afternoon hours. As Fig. 5 confirms, there are more conflict situations in the eastern compared to the western approach. One reason could be that many cyclists who are cycling from north to south are using the eastern side of the intersection. As car drivers do not expect cyclists moving on this side, some near accidents may be registered here [LW19]. There are still traffic safety problems at Haadwei-Foarwei as priorities are not clear to the traffic participants what can also be confirmed by local media reports about a car accident in August 2020 [RTV20].

Conflict levels tend to be lower compared to Haadwei-Thiedamwei. Especially the western and eastern axis show very low risk levels. The northern axis seems to be the most conflicting spot. The southern axis tends to be more conflicting compared to the west and the east. According to speed and PET the whole traffic safety situation seems to be more critical at Haadwei-Thiedamawei compared to Haadwei-Foarwei.

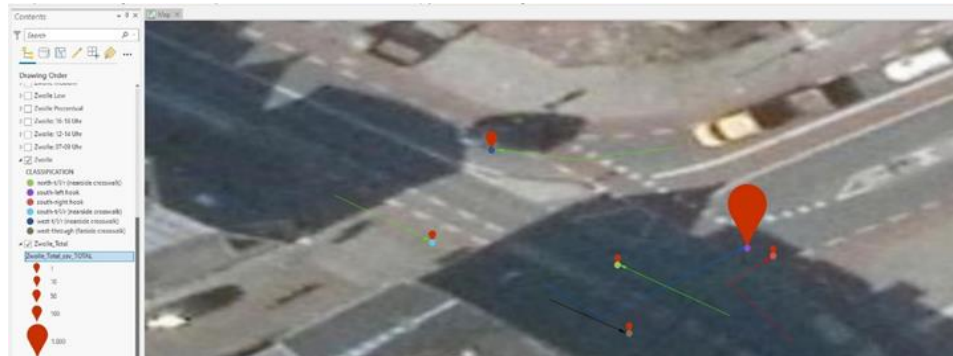
Fig. 3: Near Accidents at Assendorperstraat/Luttenbergstraat. Source: ArcGIS, copyright by Esri.

The detection of the near accidents was conducted at six days in March 2020 from 6 am to 10 pm. The overwhelming majority of the near accidents is happening when vehicles turning to the left from Assendorperstraat to Luttenbergstraat (see Fig. 3). More than 900 (>85 percent) of the 1050 detected situations are happening when cyclists crossing the bike path. Only a very small number of situations occurring at other spots.

A look to the relation of the speed levels and the time to collision shows a slightly different image. The most critical situation that may occur is still a vehicle that turns from the Assendorperstraat to the left into the Luttenbergstraat. Although the total number of

situations is not high at this location, an increased share of medium risk situations occurred when cyclists crossing the Assendorperstraat straight to the Southwest into the Bartjenstraat. Many vehicles are crossing the Assendorperstraat with high speed.
